TD-04-039  
10/04

## EDDY CURRENT SCANNING REPORT

### FNAL-3RDHARMONIC CAVITY #2

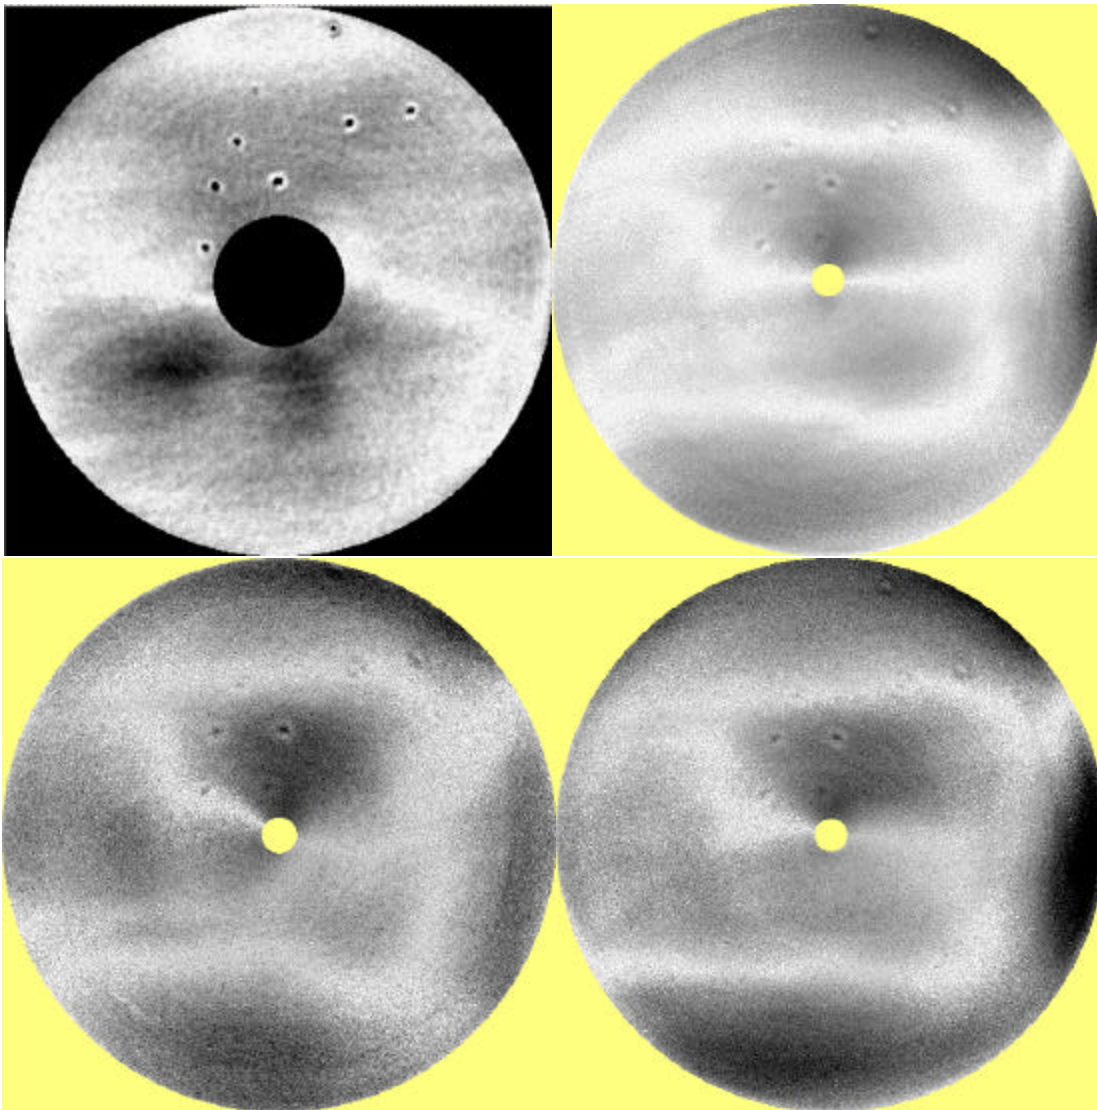
<sup>1</sup> 3<sup>rd</sup> harmonic – batch 1 – disc 22- side 2 is the disc showing the clearest evidence of defects in the DESY and FNAL scans (see **Figure 4**).

Figure 4: Example of eddy current scans performed on a niobium disc for Fermilab's 3<sup>rd</sup> harmonic cavity with the DESY scanner (top left) and SNS/FNAL scanner (top right and left & right bottom).

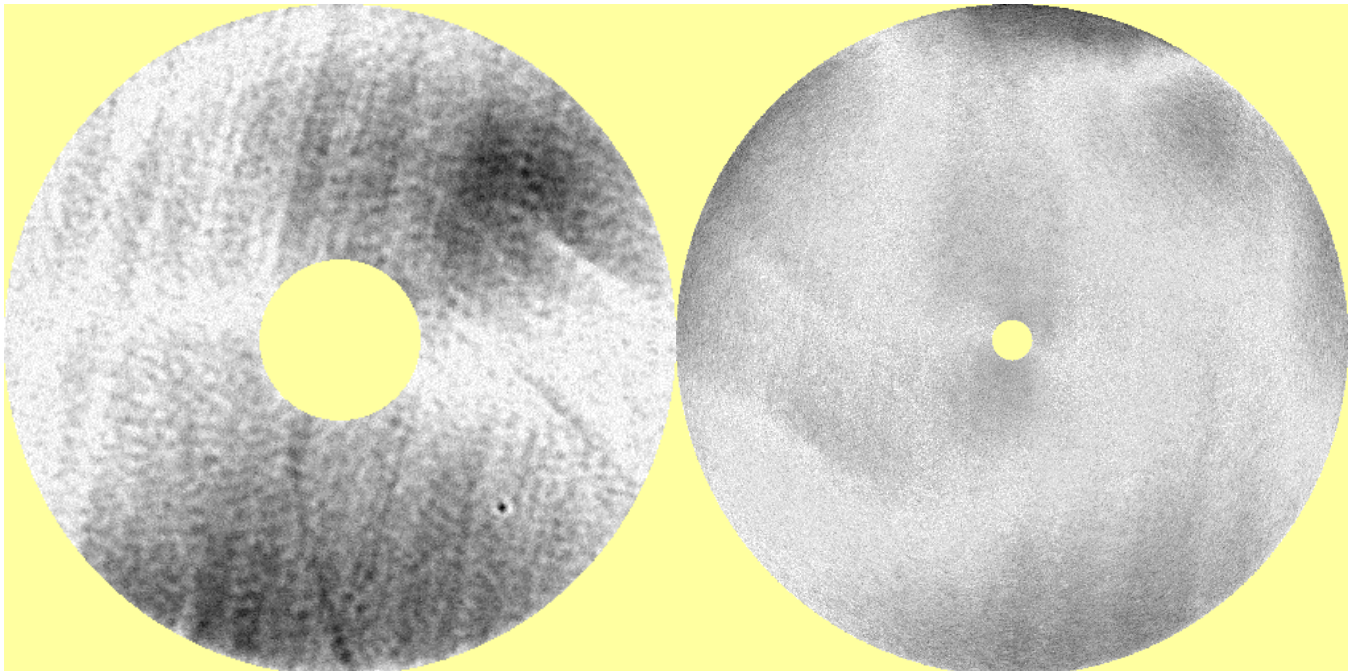
| # | disc | comment |
|---|---|--|
| 1 | 1 | S1: ok<br>S2: scratch 0 MR ( <b>defect 120 HR in DESY scan</b> )<br>Large thickness variation |

Disc 1 – side 2: DESY (left), SNS/FNAL (right), defect found in DESY scan;

| # | SIDE 1 | SIDE 2 | ADD. COMMENT | RECOM |
|---|--|---|--|---|
| 1 | OK | defect (ECS), scratch (VI) | S2 scratched from scanning | S1 |

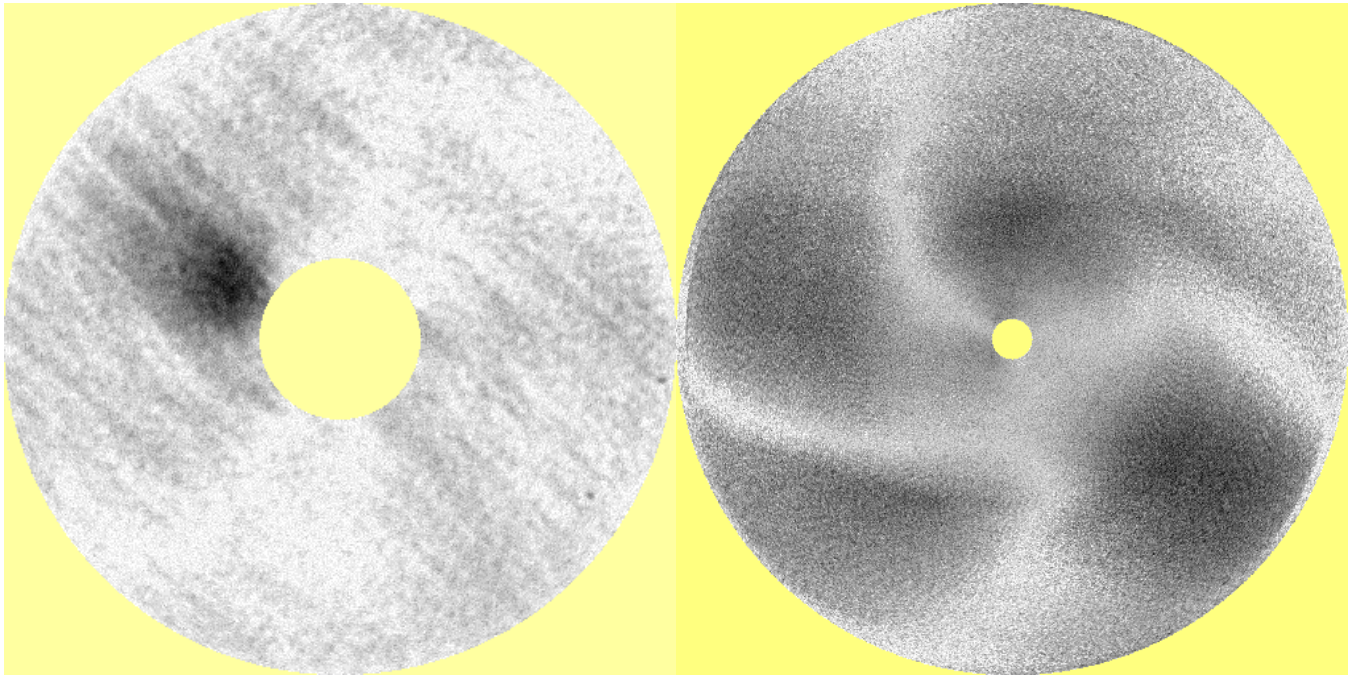
| # | disc | comment |
|---|---|--|
| 8 | 8 | S1: pits 70 OR, scratch 180 MR, oxidation from EDM cutting OR, ( <b>marked by DESY</b> )<br>S2: scratches 0 & 180 MR |

Disc 8 – side 1: DESY (left), SNS/FNAL (right), defect found in DESY scan;

| # | SIDE 1 | SIDE 2 | ADD. COMMENT | RECOM |
|---|--|---|--|---|
| 8 | defects (ECS), pits & scratches from scan (VI) | scratches (VI) | S1 scratches removed with ~50 µm etch | S1 * |

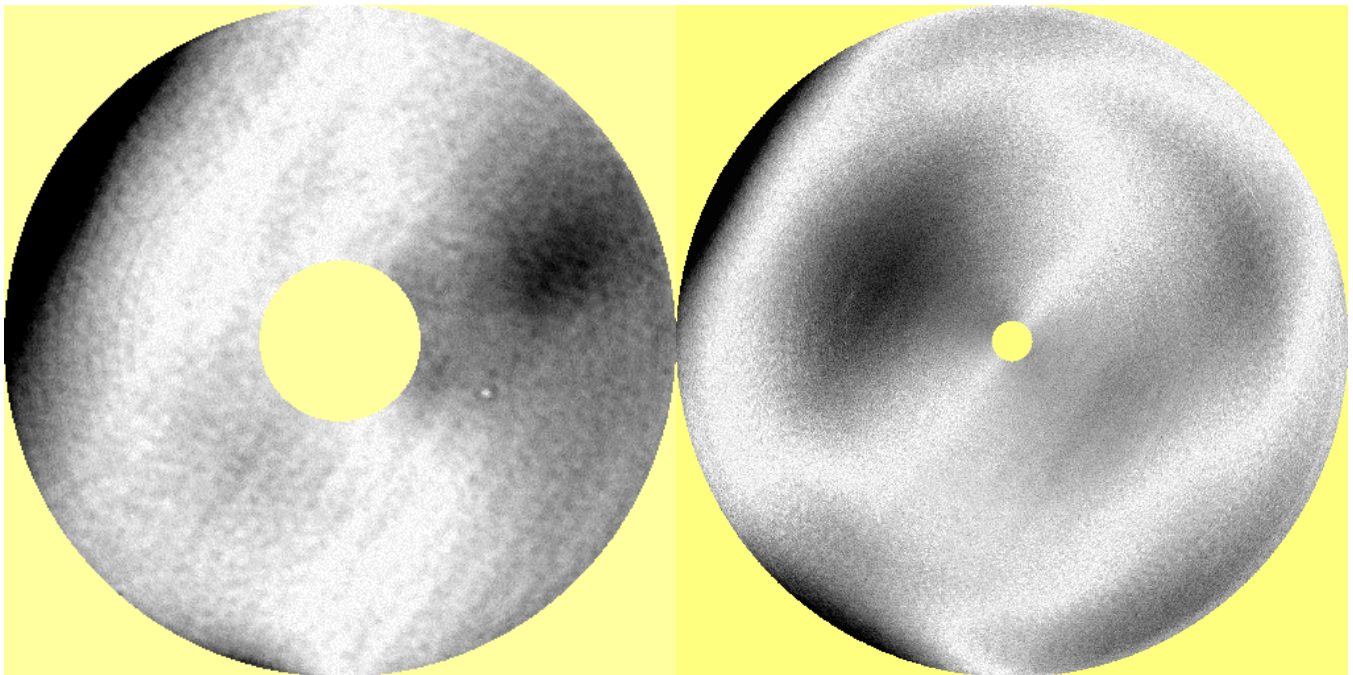
| # | disc | comment |
|---|---|--|
| 12 | 12 | S1: <b>surface scratches</b><br>S2: black speck 210 OR ( <b>marked by DESY</b> ) |

Disc 12 – side 2: DESY (left), SNS/FNAL (right), defect found in DESY scan;

| # | SIDE 1 | SIDE 2 | ADD. COMMENT | RECOM |
|---|--|---|--|---|
| 12 | scratches (VI) | defect (ECS), scratches (VI) | S2 scratched from scanning, S1 scratches removed ~50 µm etch | S1 * |

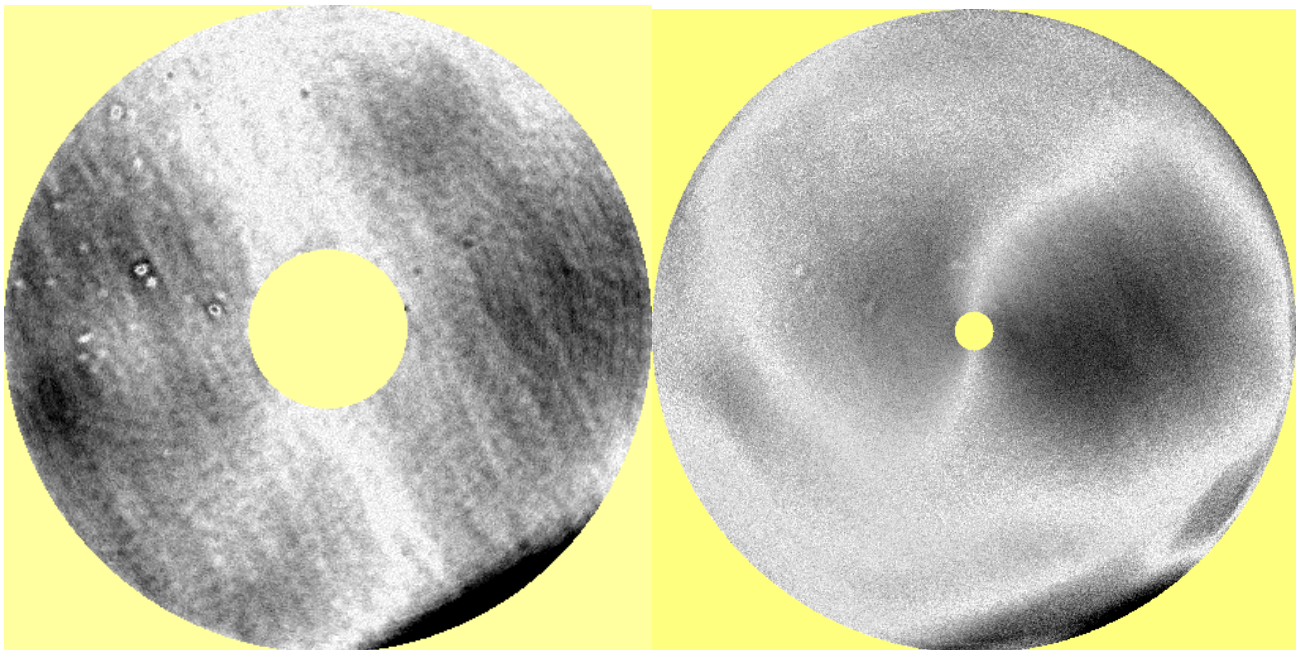
| # | disc | comment |
|---|---|--|
| 14 | 14 | S1: <b>dent 200 HR</b> , dent 25 OR<br>S2: <b>pits 0-90 &amp; 260-360 HR, scratches HR-OR (13 defects 285 HR in DESY scan)</b> |

Disc 14 – side 2: DESY (left), SNS/FNAL (right), defects found in DESY scan;

| # | SIDE 1 | SIDE 2 | ADD. COMMENT | RECOM |
|---|--|---|--|---|
| 14 | dent (VI) | defects (ECS), pits (VI) | not usable after 175 µm etch | NO |

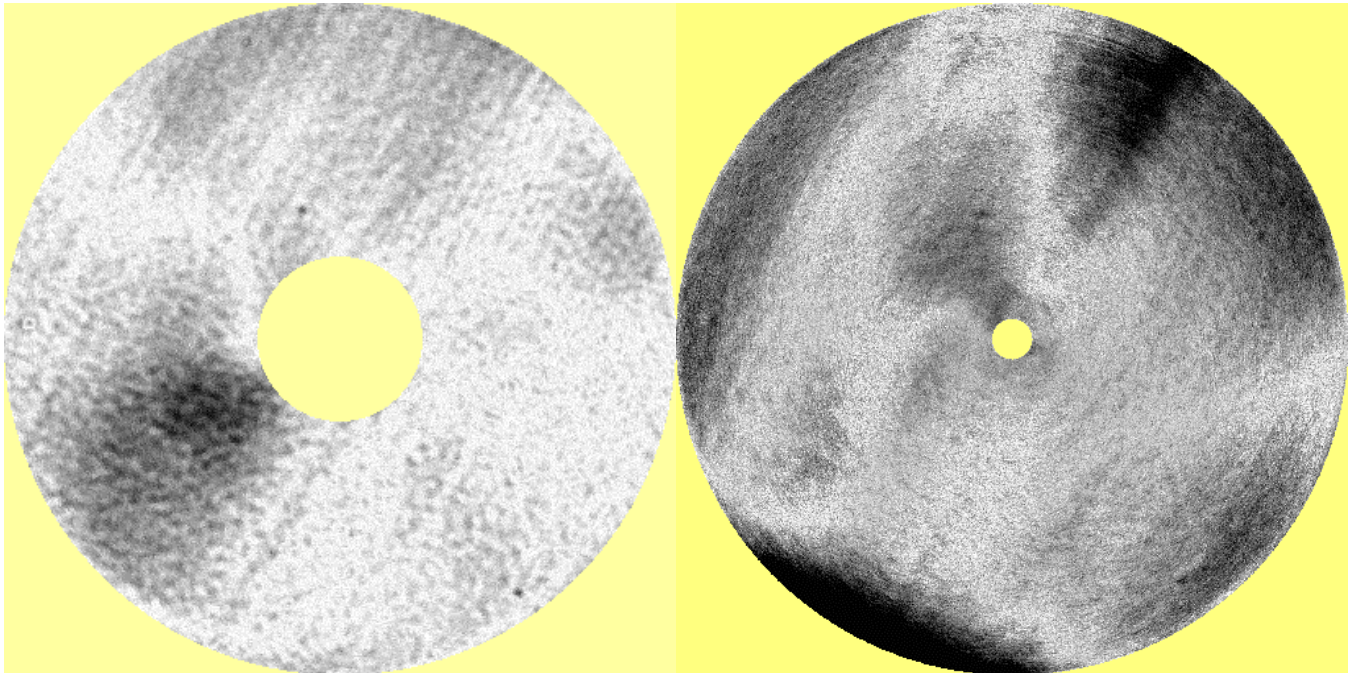
| # | disc | comment |
|---|---|--|
| 16 | 17 | S1: <b>pits 310-360 &amp; 150 HR, scratches (marked by DESY)</b><br>S2: scratch 0 MR, specks 120-140 HR |

Disc 17 – side 1: DESY (left), SNS/FNAL (right), defect found in DESY scan;

| # | SIDE 1 | SIDE 2 | ADD. COMMENT | RECOM |
|---|--|---|--|---|
| 17 | defects (ECS), pits (VI) | scratches (VI) | S1 scratched from scanning, S2 scratches removed w ~50 µm etch | S2 * |

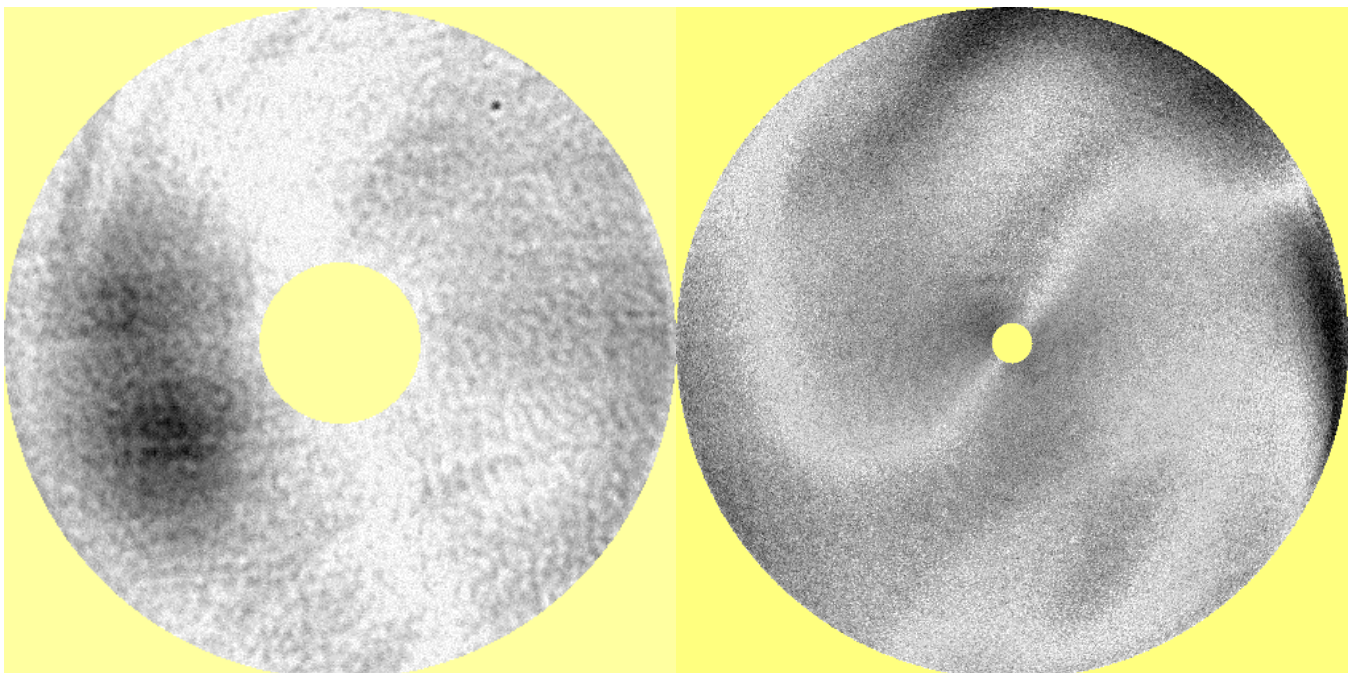
| # | disc | comment |
|---|---|--|
| 17 | 19 | S1: pit 75 OR, scratch 300 OR<br>S2: <b>scratches, dent 30 HR (defect 12 HR in DESY scan)</b> |

Disc 19 – side 2: DESY (left), SNS/FNAL (right), defect found in DESY scan;

| # | SIDE 1 | SIDE 2 | ADD. COMMENT | RECOM |
|---|--|---|--|---|
| 19 | long (shallow?) scratch (VI) | defect(ECS),pits&scratches (VI) | disc etched 50 µm | NO(S1) |

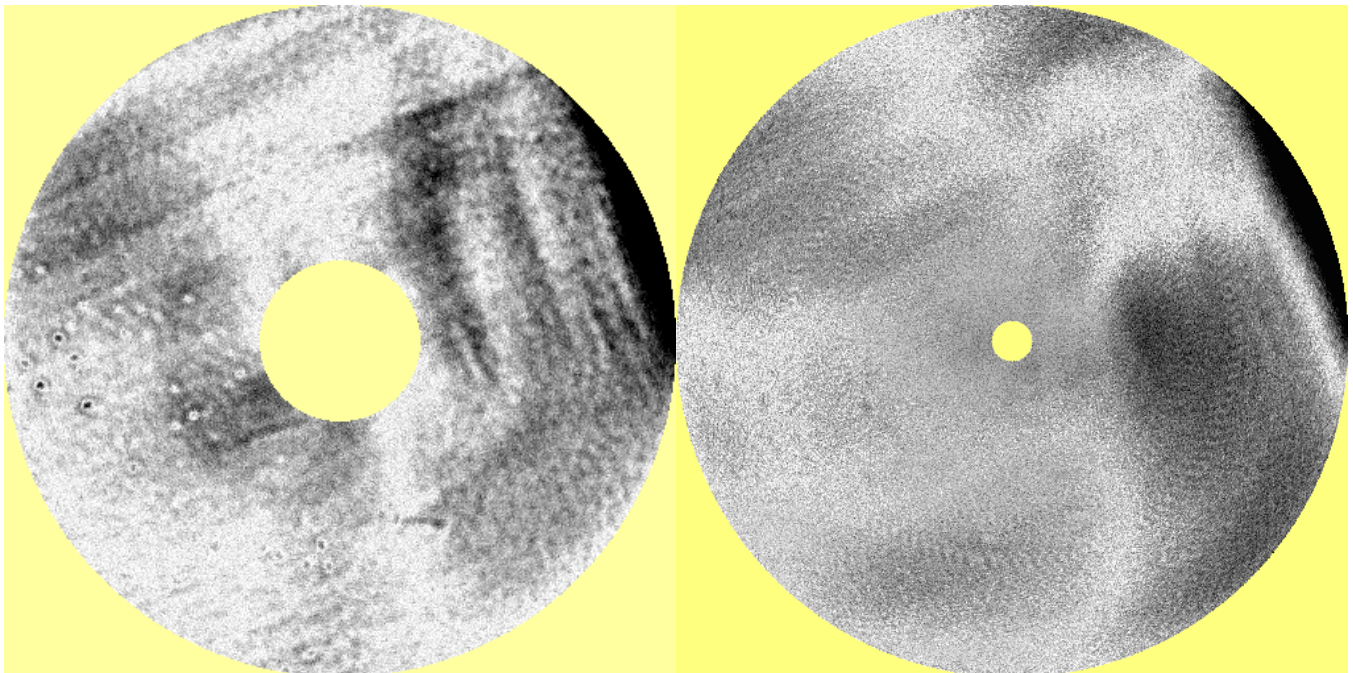
| # | disc | comment |
|---|---|---|
| 21 | 27 | S1: ok<br>S2: scratch 140 HR, pits 170-300, ( <b>13 defects 180 &amp; 270 HR in DESY scan</b> ) |

Disc 27 – side 2: DESY (left), SNS/FNAL (right), defects found in DESY scan;

| # | SIDE 1 | SIDE 2 | ADD. COMMENT | RECOM |
|---|--|---|--|---|
| 27 | small scratch, weak scan marks | defects(ECS), pits&scratches(VI) | - | S1 |

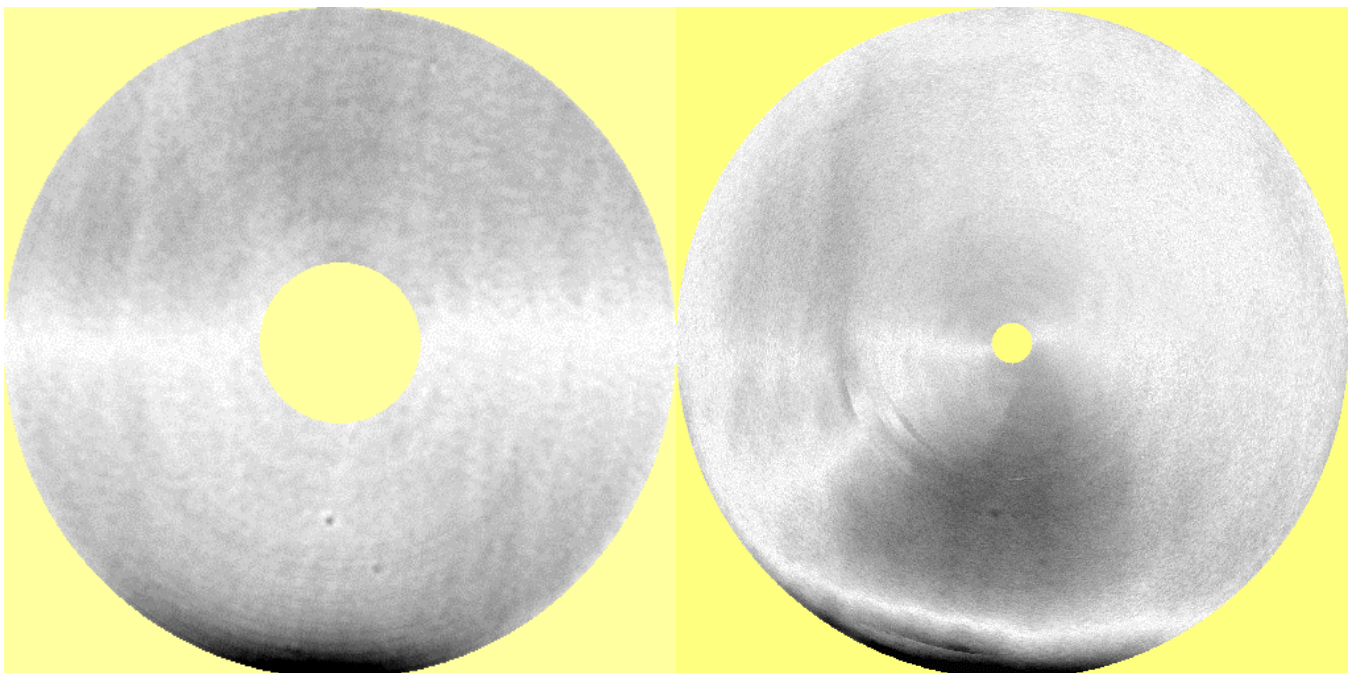
| # | disc | comment |
|---|---|---|
| 22 | 32 | S1: <b>ding 40 OR-HR</b><br>S2: <b>scratches, dings and specks 170-200 HR (defect 180 HR in DESY scan)</b> |

Disc 32 – side 2: DESY (left), SNS/FNAL (right), defects found in DESY scan;

| # | SIDE 1 | SIDE 2 | ADD. COMMENT | RECOM |
|---|--|---|--|---|
| 32 | dent (VI) | defects(ECS), pits&scratches(VI) | S1 scratches removed with ~50 µm etch | S1 * |

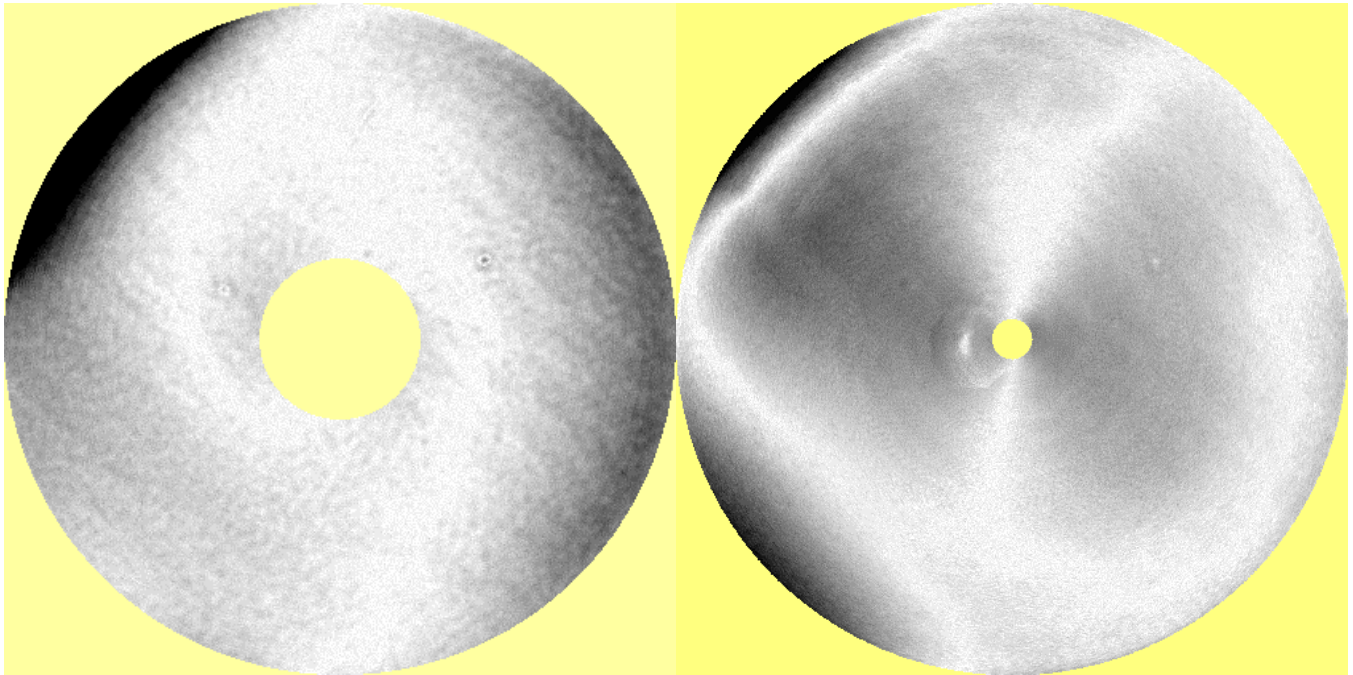
| # | disc | comment |
|---|---|---|
| 25 | 47 | S1: <b>scratches HR, ding 75 HR, pits 290 HR (defect 75 HR in DESY scan)</b><br>S2: ok |

Disc 47 – side 1: DESY (left), SNS/FNAL (right), defects found in DESY scan;

| # | SIDE 1 | SIDE 2 | ADD. COMMENT | RECOM |
|---|--|---|--|---|
| 47 | defect (ECS), pits&scratches (VI) | OK | - | S2 |

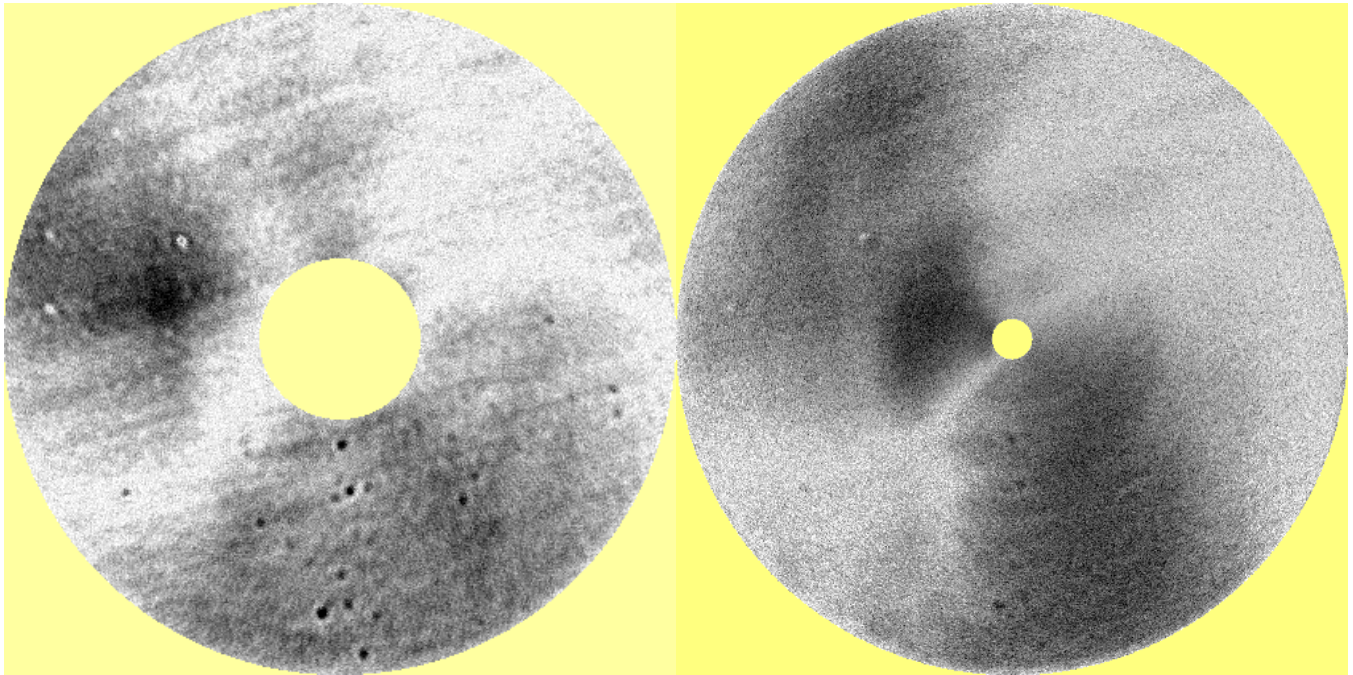
| # | disc | comment |
|---|---|---|
| 26 | 51 | S1: pits all over HR ( <b>many defects 180 &amp; 270 HR in DESY scan</b> )<br>S2: scratch MR |

Disc 51 – side 1: DESY (left), SNS/FNAL (right), defects found in DESY scan;

| # | SIDE 1 | SIDE 2 | ADD. COMMENT | RECOM |
|---|--|---|--|---|
| 51 | defects (ECS) pits&scratches (VI) | scratch MR&weak scanmarks(VI) | - | NO(S2) |

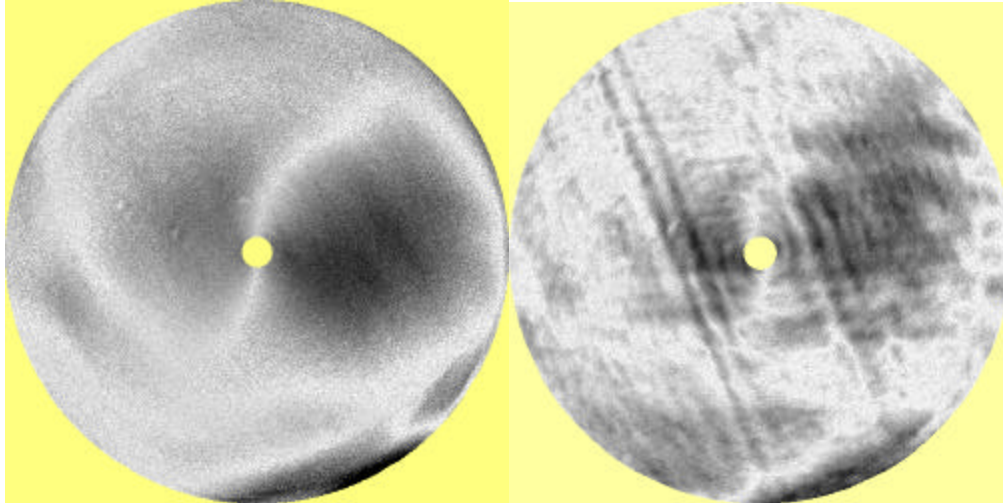
Figure 5 shows the results of eddy current scans performed with the SNS/FNAL scanner on disc 14-2 before and after removing  $175\text{ }\mu\text{m}$  with BCP etching. The plots clearly show a change of appearance of the scan, possibly a result of the increase of surface roughness due to the BCP etching. The change of surface appearance can also be seen in Figure 6, which shows a similar comparison for disc 14 – side 1 (which had not visible defects before etching) and Figure 7, which shows a similar comparison for disc 19 – side 2. Also, and this is corroborated by simple visual inspection, most defects are still present after etching. This result indicates that the defects found in some blanks from this batch will not be removed by the subsequent etching steps and that these particular disc-sides should not be used for the inside of the cavities. Since the total surface removed with BCP etching according to the current cavity fabrication procedure is  $50\text{ }\mu\text{m}$  less than the  $175\text{ }\mu\text{m}$  removed in this test, this test also addressed the possibility of an additional  $50\text{ }\mu\text{m}$  pre-etching. More than  $50\text{ }\mu\text{m}$  of pre-etching is not permitted since the thickness variations of the discs will be larger than allowable for welding and deep-drawing (one also needs to include the “natural” thickness variation of the discs of up to  $100\text{ }\mu\text{m}$ !).

**Figure 5: Scan of disc 14/2 before (left) and after (right) 175 mm were removed with BCP etching.**

Tests on disc 14 have revealed that these defects are not removed even after 175  $\mu\text{m}$  of BCP etching. Therefore it is not recommended to use these sides of the discs on the inside of the cavity, even after some pre-etching.

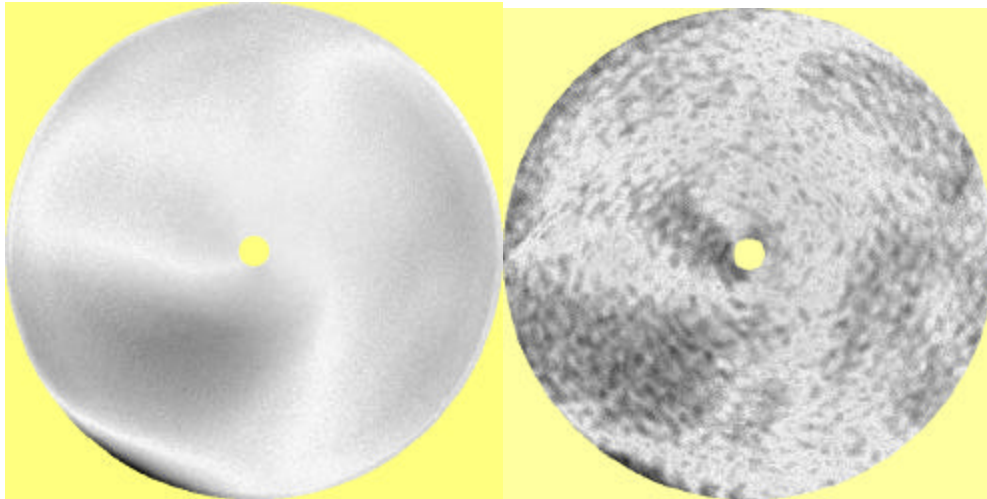
**Figure 6: Scan of disc 14/ 1 before (left) and after (right) 175 mm were removed with BCP etching.**

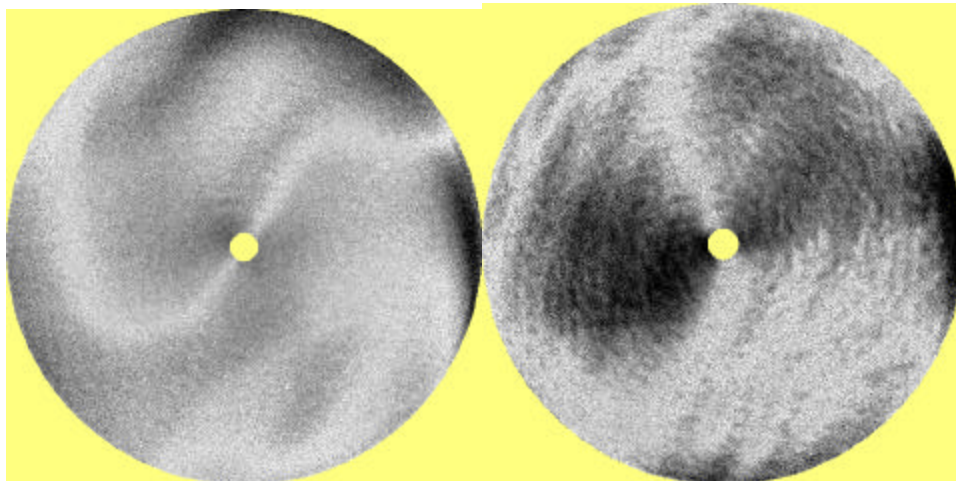
**Figure 7: Scan of disc 19/2 before (left) and after (right) 50 mm were removed with BCP etching.**
